## MAIN FINDINGS AND RECOMMENDATIONS FROM THE WHO/EUROPE MISSION TO HUNGARY

12 -16 October 2010

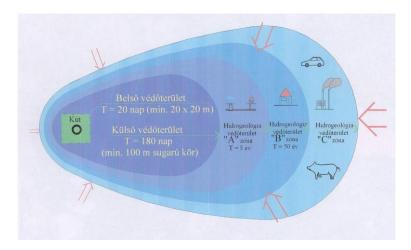
- The team visited the Bakonykarszt Viz és Csatornamű plc. water supply and sewage company. The company supplies water and sanitation services to 220,000 people for a daily average flow of 25, groundwater 000 30,000 m3/day. The company uses a mixture of resource waters: 82% of this is of karstic origin, 7% is groundwater and 12% is confined deep aquifer. Treatment consists of oxidation for the removal of Fe and Mn, filtration and disinfection by means of sodium hypochlorite. Treatment is done on location of the capture area.
- Hungarian law requires a tiered protection zoning scheme around water extraction points, based on the hydrogeological characteristics. For zone A the

hydrogeological flow is 5 years, for zone B 50 years and, for zone "C" comprises the entire drainage area. Human habitation is permitted in zone B, industry in zone C.

Protection zone system (Source: Bakonykarszt Viz és Csatornamű plc. water supply and sewage company)

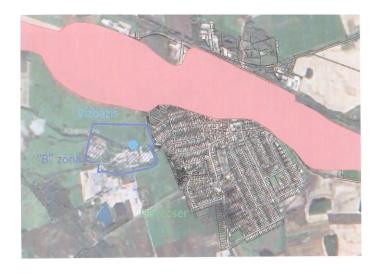
• There are two water extraction points in the affected zone: one in Devecser, consisting of two deep wells where the red mud did not reach zone B and one in Somlóvásárhely where the red mud did reach zone B. In both cases, the protection zones had been established based on tritium tests done in 2006. The test showed perfect protection in Somlóvásárhely, but less than the standard requirements for protection in Devecser. This deviation from the standard is however of no significance from a health point of view

Water abstraction Devecser with "B" zone protection (Source: Bakonykarszt Viz és Csatornamű plc. water supply and sewage company)

- The water company proposed to develop monitoring boreholes between the contaminated sites and the water abstraction points on the border of the protection zone B in Devecser to allow surveillance of any heavy metal movement in groundwater.

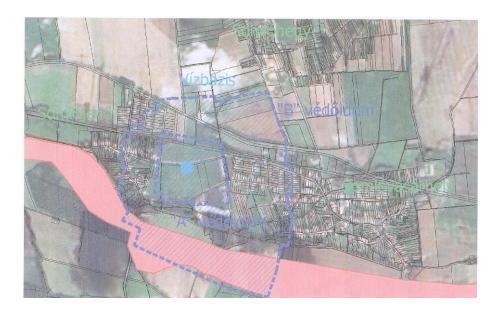
Water abstraction point in Somlóvásárhely showing the penetration of the red mud in the "B" protection zone (Source: Bakonykarszt Viz és Csatornamű plc. water supply and sewage company)

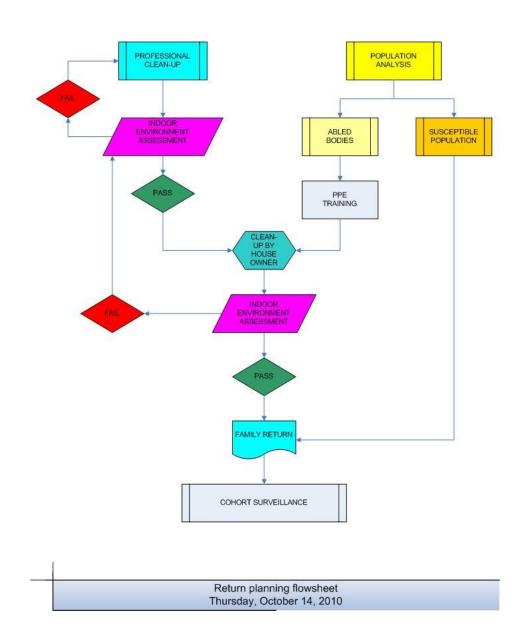
#### ANNEX 3:FLOW CHART FOR THE RETURN OF THE POPULATION

- Temporarily displaced population need to be advised about options available to them regarding the safe return home, relocation, refurbishing of damaged houses or compensation, as uncertainty in this essential matter is a major source of stress and frustration. Timely communication from credible channels is important to address these important concerns.
- The return of evacuated population to their homes should only take place following remediation and clean up, coupled with exposure assessment (e.g. to polluted air), as well as assessment of conditions that could increase the vulnerability of some individuals, such as children, pregnant women, elderly and people with preexisting conditions (see Annex 3 for details).
